Background Report
Natural Conditions
December 2003

Seattle's Central Waterfront Plan: Study Area

Natural Conditions

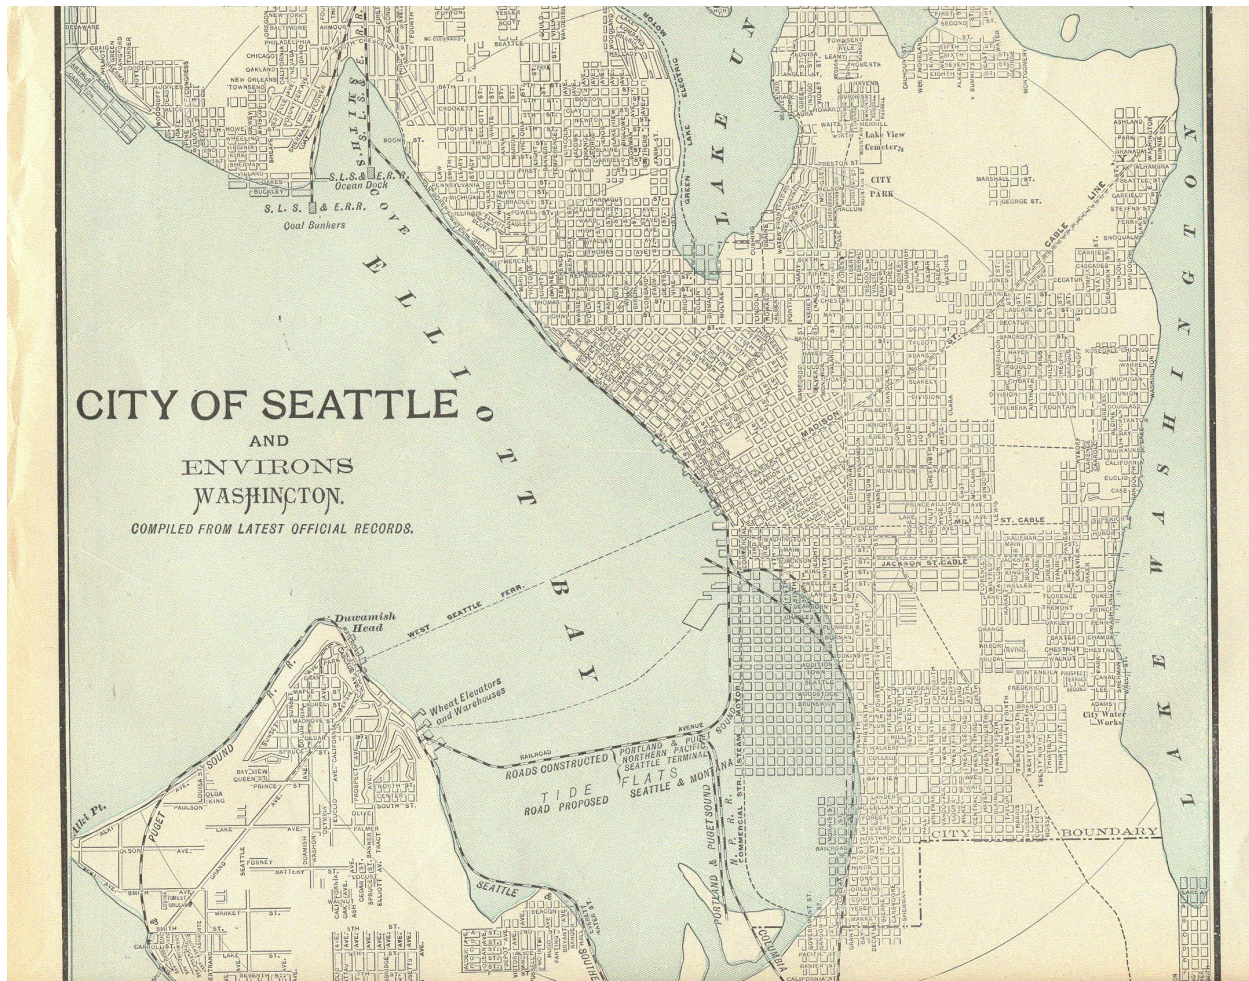
Figure 1. Early Shoreline Conditions

In recent history, the greatest modifications to this environment have occurred through urbanization. In the early 1800's the tide flats extended eastward to the base of Beacon Hill, and Harbor Island did not exist. As shown on Figure 1, the southern portion of Pioneer Square, the area that is now Terminal 46, and the Duwamish industrial area were all part of an expansive mudflat—unbuildable due to inundation by tidewaters.

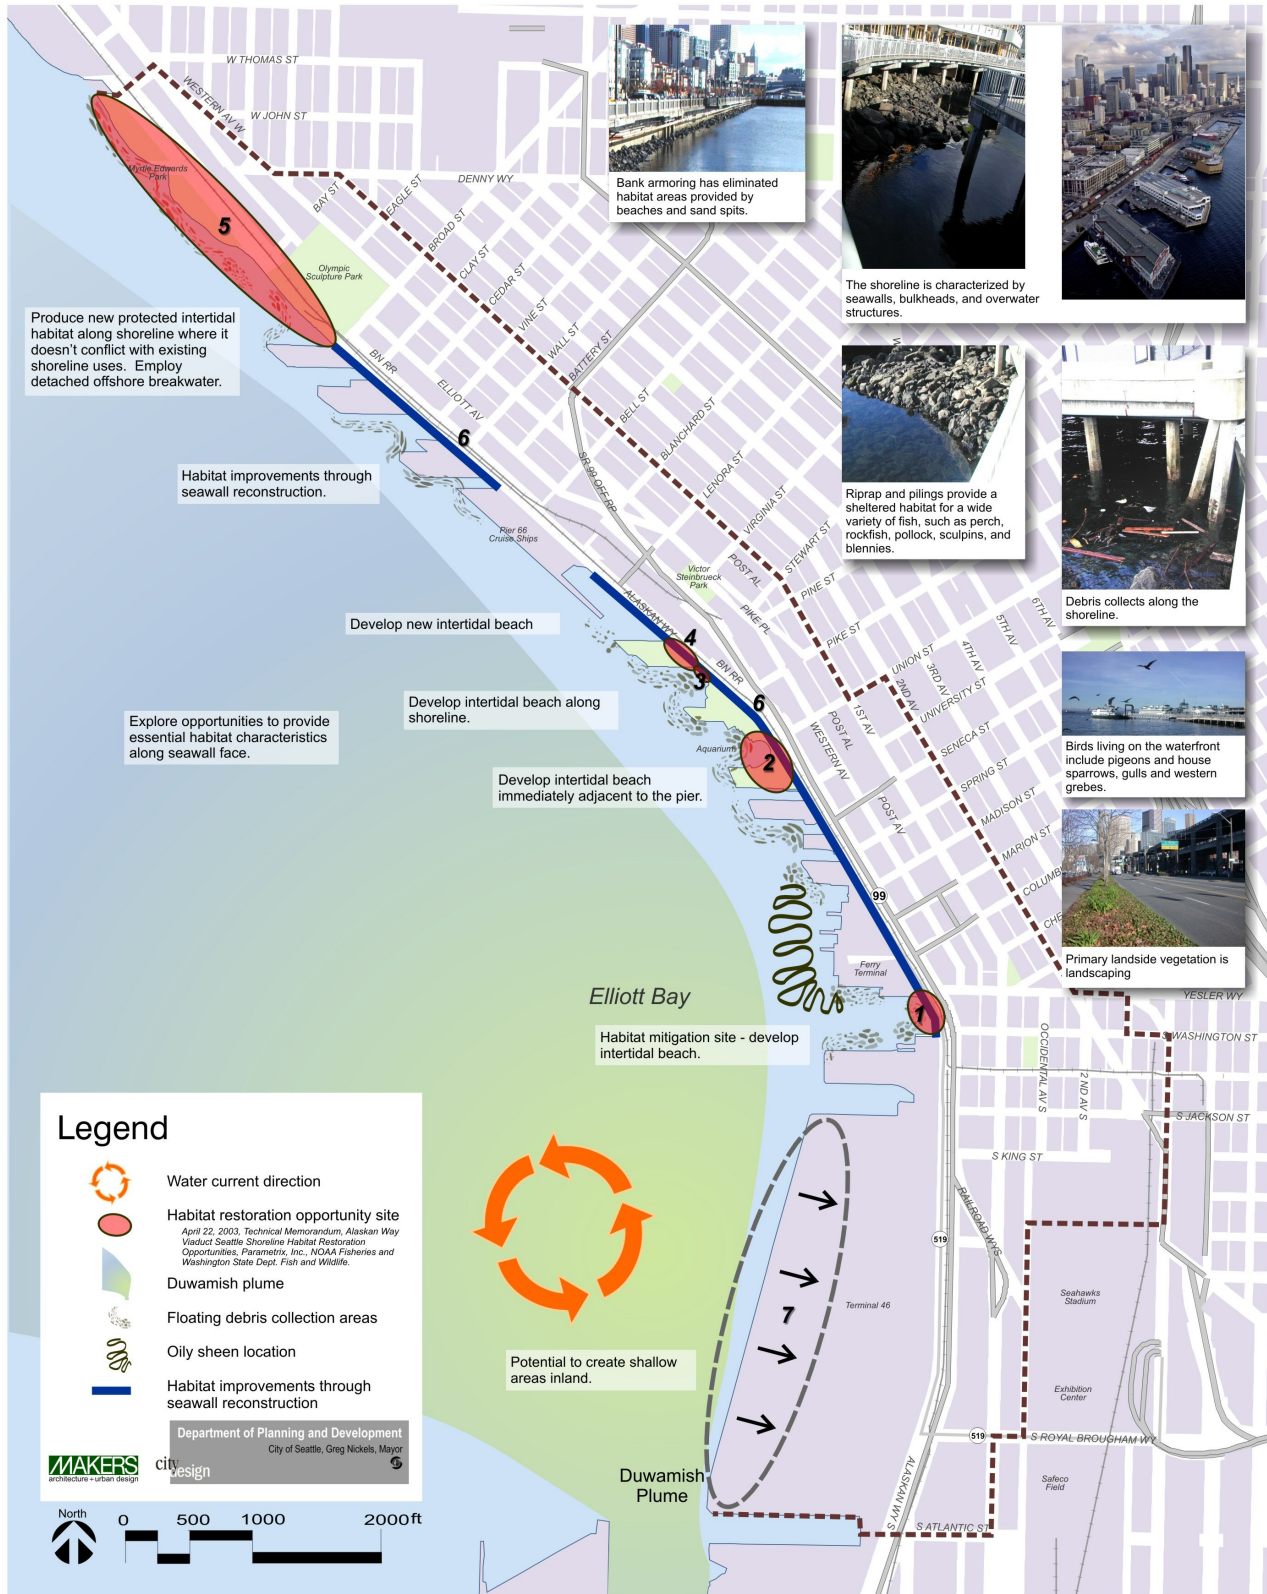
Figure 4. Habitat Restoration Opportunities

There are a number of open areas along the existing waterfront where the shoreline is not committed to commercial uses. These open spaces offer limited but substantial opportunities to restore natural habitat functions through an approach that would restore some of the shallow water functions needed by young salmon as they migrate along the Seattle waterfront. Because of the substantial length of shoreline involved, it may be desirable to develop several habitat restoration areas that would help to restore a connected corridor.⁷ The bathymetry is a major determinant in identifying potential restoration site(s). Figure 3, Waterfront Bathymetry, shows at a larger scale the depth of the water in the Central Waterfront nearshore environment, where conditions are most critical for habitat. Areas less than 20 feet deep may offer better rehabilitation opportunities than deeper water areas. The following is a brief summary of habitat restoration opportunities identified for consideration as part of the Alaskan Way Viaduct environmental evaluation, which are shown in Figure 4.

- 1. Pier 46 to 48.** One habitat mitigation site is located between the Washington Street Public Boat Landing and Colman Dock, where large rocky substrate has been placed and acts as a site for algal community development and interstitial cover for fish and invertebrates. Develop an intertidal beach complex that is protected by an arch shaped extension roughly following the Pier 48 alignment or possible other alignment with redevelopment of Colman Dock. Could involve removal of Pier 48 and construction of new beach.
- 2. Waterfront Park.** Develop an intertidal beach along the areas immediately adjacent to the Waterfront Park pier.

3. **Seattle Aquarium.** Develop an intertidal beach along the shoreline between the Seattle Aquarium and Pier 63.
4. **Pier 62/63.** Develop a new intertidal beach habitat along most of the shoreline portions of the piers. Involves removal of piles and decking along most of seawall to expose shoreline, while retaining narrow access connection to Piers.
5. **Pier 70/Myrtle Edwards Park Shoreline.** Produce new protected intertidal habitat along a substantial length of shoreline north of Pier 70 where it will not conflict with existing shoreline uses. Employ a detached offshore breakwater concept to protect shoreline habitat from wind waves and vessel wakes that commonly reach this shoreline with considerable force.

6. **Seawall Reconstruction.** As part of seawall replacement, explore opportunities to provide the essential habitat characteristics along the face of the seawall where replacement may not allow development of fill providing sloping intertidal habitat. These ideas range from increasing complexity cast in the seawall itself to the creation of shelves or benches on the face of the seawall to provide access to shallower water at various tidal elevations.
7. **Terminal 46.** While outside the area addressed in the paper, here is potential to create shallow water inland as a part of future development.

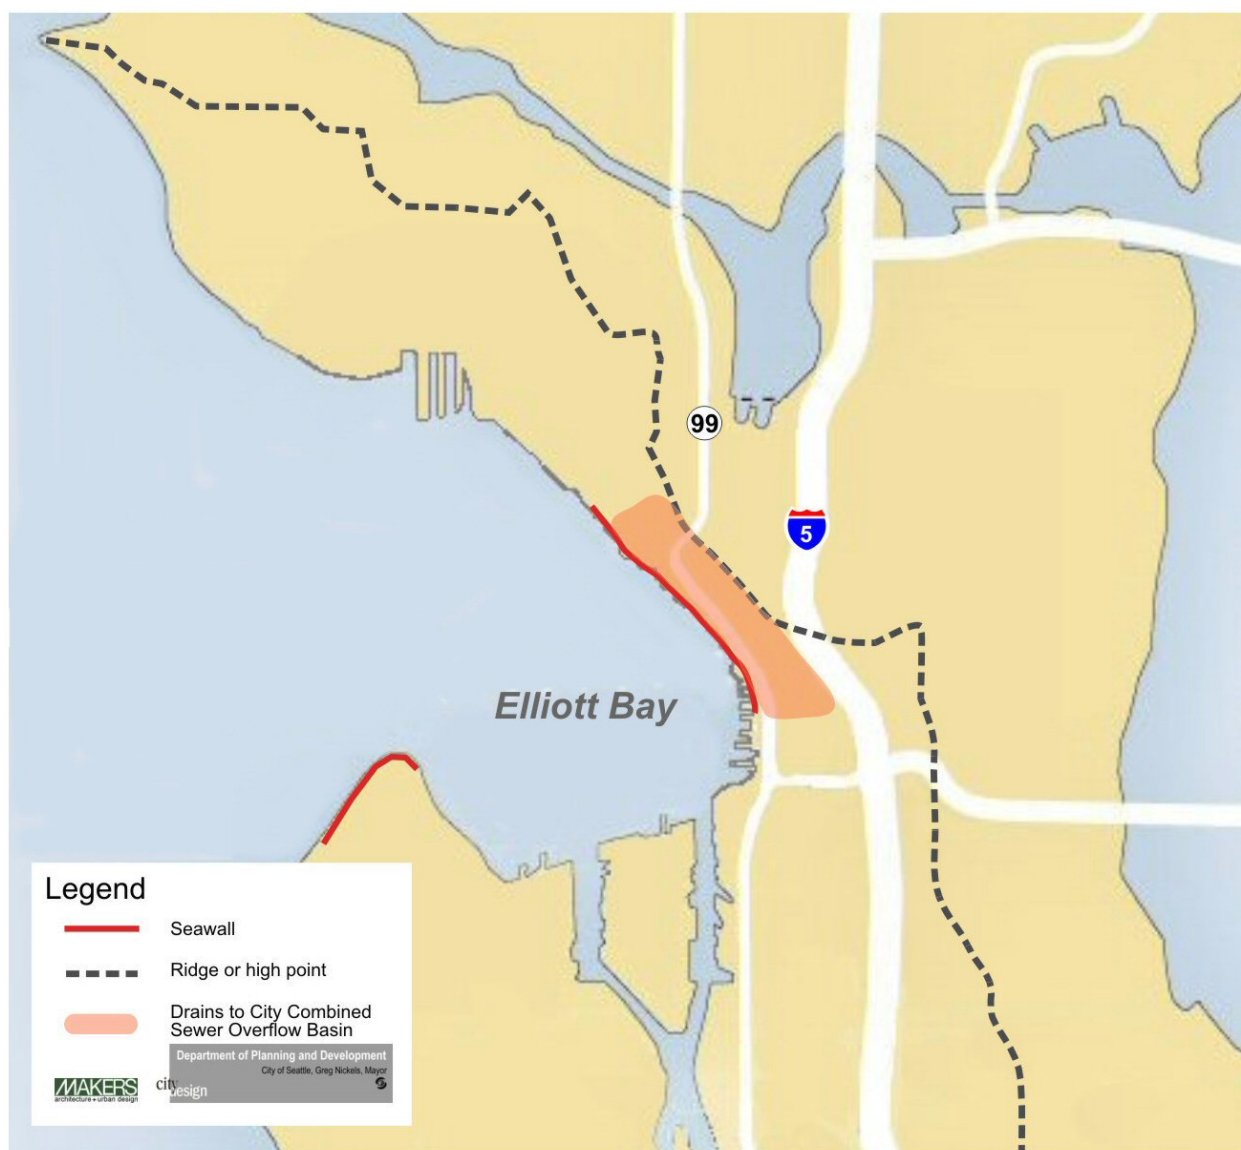
Figure 5. Drainage into Study Area

Thirty-five CSOs and storm drains discharge to the shore of Elliott Bay and the East and West Waterways. Combined Sewer Overflows (CSOs) discharge organic and inorganic substances from untreated sewage during stormwater overflow, although about 90 percent of discharges consist of stormwater. Recognition that even stormwater has the potential to carry pollutants from the urban the urban environment has spurred innovative infrastructure improvements. At some locations, the first flush of a storm is diverted to the sewage treatment plant while later rainfall accumulations continue to discharge directly into the Bay.
